Paint Thickness Measurements on CFRP Automobile Parts

Robert Wohlleber, BMW
Bayerische Motoren Werke Aktiengesellschaft, Landshut
Johann H. Hinken, FIT-M
FI Test- und Messtechnik GmbH, Magdeburg
Germany

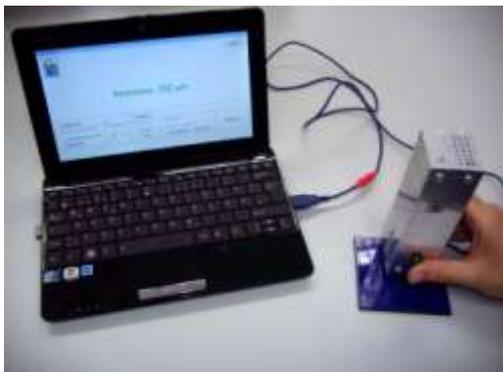
Figure 1: Paint thickness gage FSC1 consisting of the measuring module and the display module.

The paint thickness gauge FSC1/6 consists of two modules: the measurement module and the display module, see figure 1. The instantaneous measurement area is about 2 cm². The measurement time is about 2 seconds. The substrates may be isotropic or anisotropic and may have medium or high electrical conductivity

The readout is independent of the dielectric constant (permittivity) of the isolating layer. In case of layered paint material the complete thickness is measured. Usually, the calibration is performed by the user on the CFRP substrate material in use and with plastic calibration foils.
